Post Drilling/Annual Well Site Inspection Form

Location Description: 2.0 miles NNW from Little Willow Gathering Facility, 4649 Little Willow Road. Google Maps location Latitude 44.079257, Longitude -116.810886.

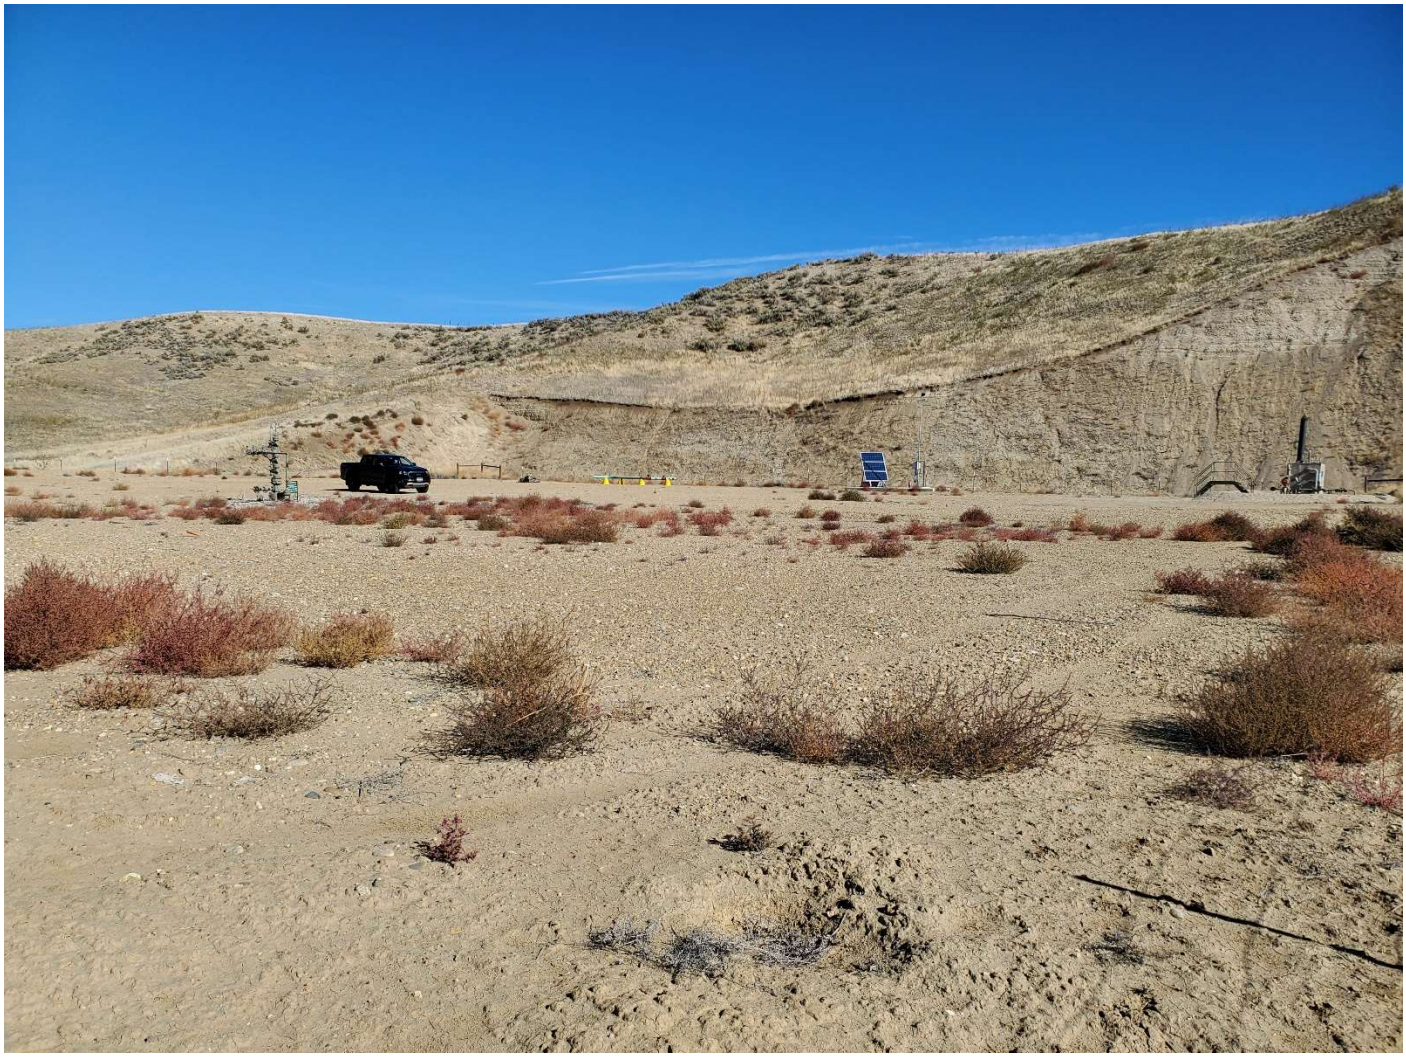
There is a constructed trench and ditch along the northwest side of the well pad, evidently to drain snow melt and spring run-off. This should be corrected.

Constructed trench to prevent pooling snowmelt and runoff, northwest side of pad. View is west.
