Post Drilling/Annual Well Site Inspection Form

Section 1: General Information	
Operation Data	Inspection Data
Operator Name Snake River Oil + Gas, LLC	Inspector Name James Thum
Well Name ML Investments #1-3, USWN 11-075-20026	Area Office Boise / Director's
Authorized Contact Dan Johaneck (208)707-7867 112 N. Plymouth, New Plymouth ID	Inspection Date 11/29/2021 2:10 PM
County Payette	Report Date 1/4/2022
Inspector's Signature: /signed/ James Thum	Inspection Summary: <input checked="" type="checkbox"/> Operation appeared to be in compliance at the time of the inspection. <input type="checkbox"/> Issues of concern identified at the time of the inspection.
Date of Signature: 1/4/2022	
Location Description: 4420 feet NNW from Little Willow Gathering Facility, 4649 Little Willow Road. Google Maps location Latitude 44.062918, Longitude -116.804583. Well is currently producing at the time of inspection. This unit includes BLM mineral interest.	
Weather: sunny, 50°F, variable light wind <5 MPH

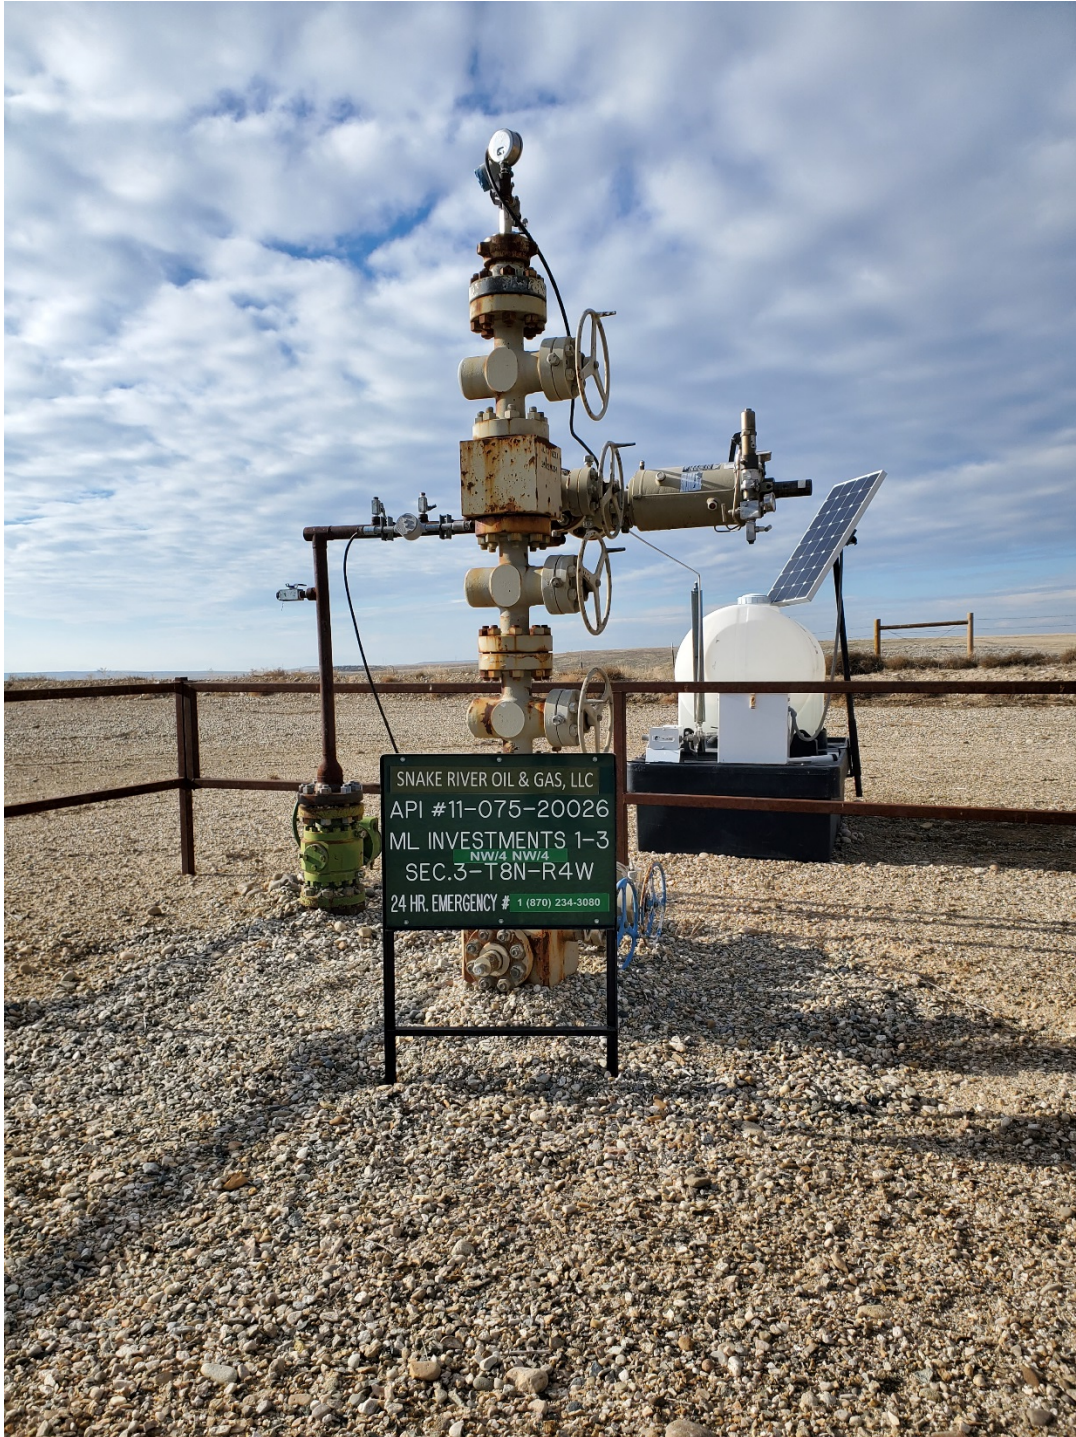
Cellar around wellhead is now gravel-filled.

1. Wellhead and chemical storage, looking WNW. Note cellar is now gravel-filled.

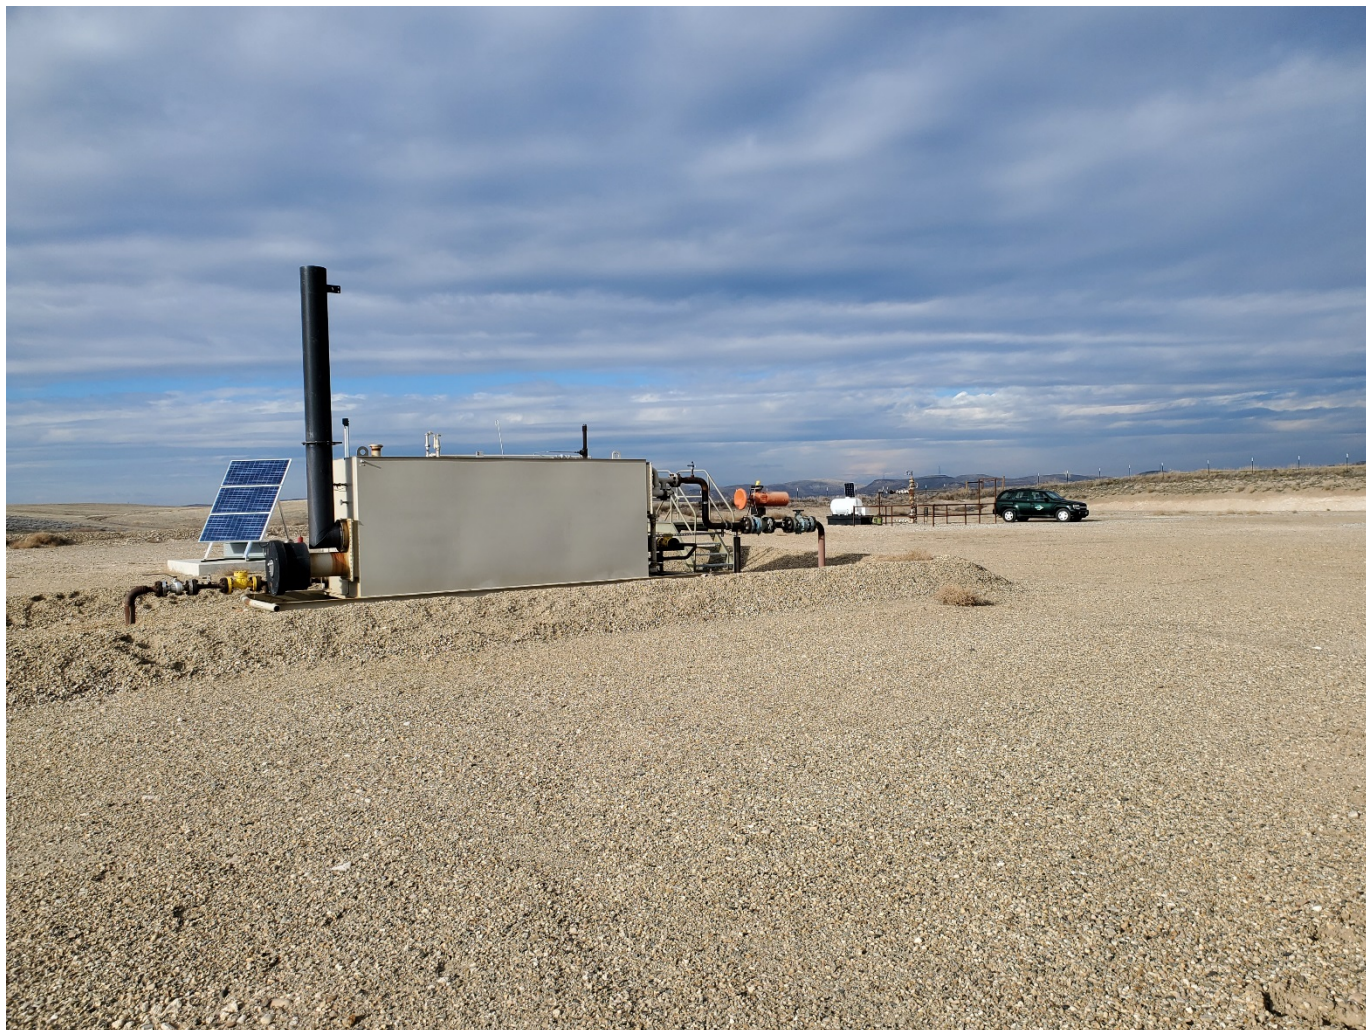
2. Separator unit, flare stack in foreground with wellhead behind and to the right, looking NW.

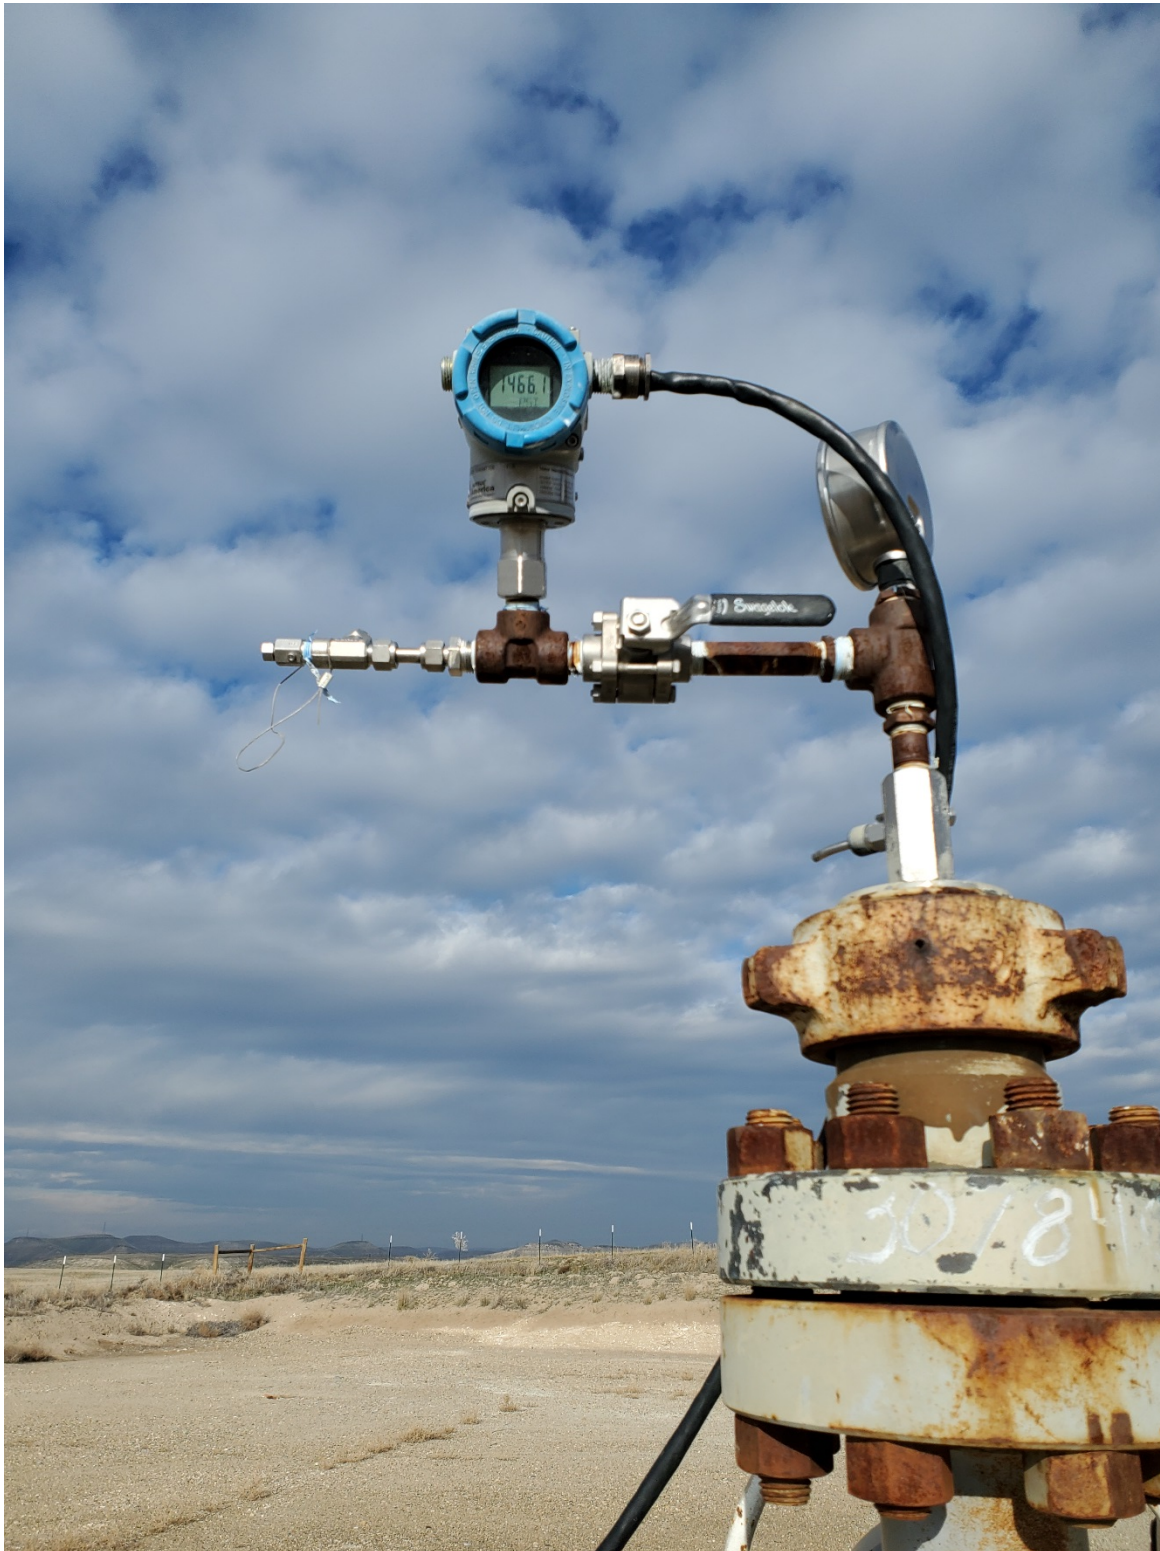
Tubing: 1465 PSI (1112 PSI reported 11/1/2021, 6 month report) note- digital and analog pressure gauges installed

3. Digital and analog tubing pressure gauges installed on wellhead.
